## Hybrid Jacketing for Rapid Repair of Seismically Damaged Reinforced Concrete Columns

Mostafa Fakharifar, Genda Chen, Mahdi Arezoumandi, and Mohamed ElGawady

*Transportation Research Record: Journal of the Transportation Research Board*, No. 2522, Transportation Research Board, Washington, D.C., 2015, pp. 70–78. DOI: 10.3141/2522-07

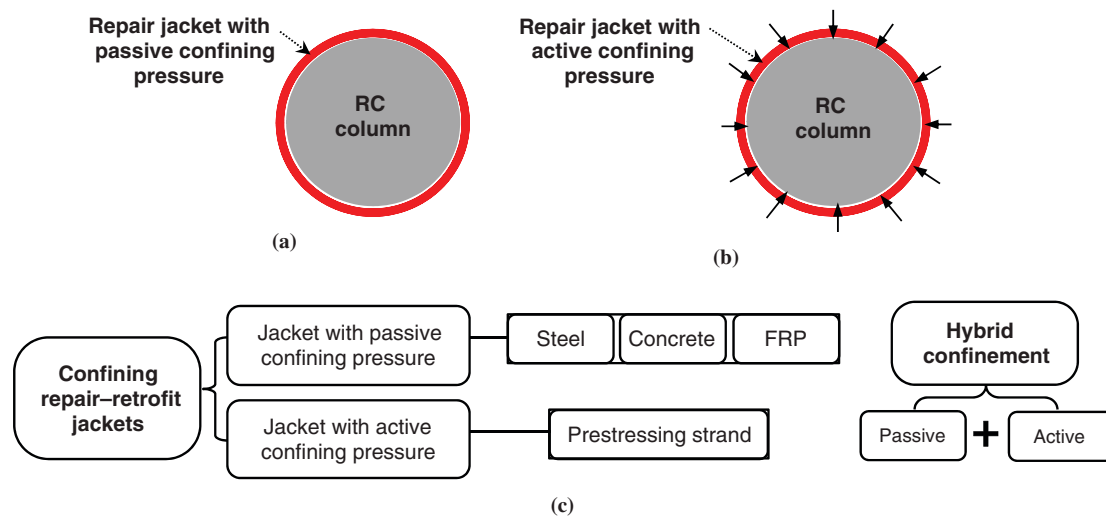
FIGURE 1 Comparison of existing retrofit and repair methods: (a) passive confinement, (b) active confinement, and (c) confining pressure from various repair jackets (FRP = fiber-reinforced polymer).

RC columns can be confined both actively and passively. With active confinement, the confining pressure is applied to concrete columns before the progression of concrete damage (3, 4, 10). With passive confinement, concrete is subjected to damage (lateral dilation) before confinement is in effect through the buildup of hoop stress (4). Figure 1, *a* and *b*, illustrates the schematics of cross sections of passively and actively confined RC columns, respectively. In general, active confinement can improve the strength and ductility of concrete more significantly than passive confinement (4, 5). Active confinement is preferred for inadequate lap-spliced columns because concrete dilation is not required to activate the jacketing pressure, as concrete lateral dilation leads to bond deterioration between lapped bars (10). Priestley et al. presented different seismic rehabilitation techniques of RC bridge columns using steel, concrete, fiber-reinforced polymer (FRP), and prestressing strands (4). Different jackets, based on the confining pressure provided, are categorized and presented in Figure 1c. Past studies proved the efficacy of different confining repair jackets (4–14). However, in addition to the high material cost and concerns about the long-term performance (prone to moisture), FRP materials were shown to suddenly rupture because of their linear elastic properties (4, 12). Although thick steel jackets were available and economical with ductile behavior, material handling and high field installation costs were their major drawbacks (3, 4). Lin et al. successfully implemented a seismic retrofitting system with active confinement using prestressing strands (5). However, tests indicated that the columns retrofitted with prestressing strands experienced strength deterioration under cyclic loading caused by high losses of the prestressing force in confining strands. The concrete cover spall

during cyclic reversals and the penetration of prestressed strands into the concrete caused the loss of confining force.

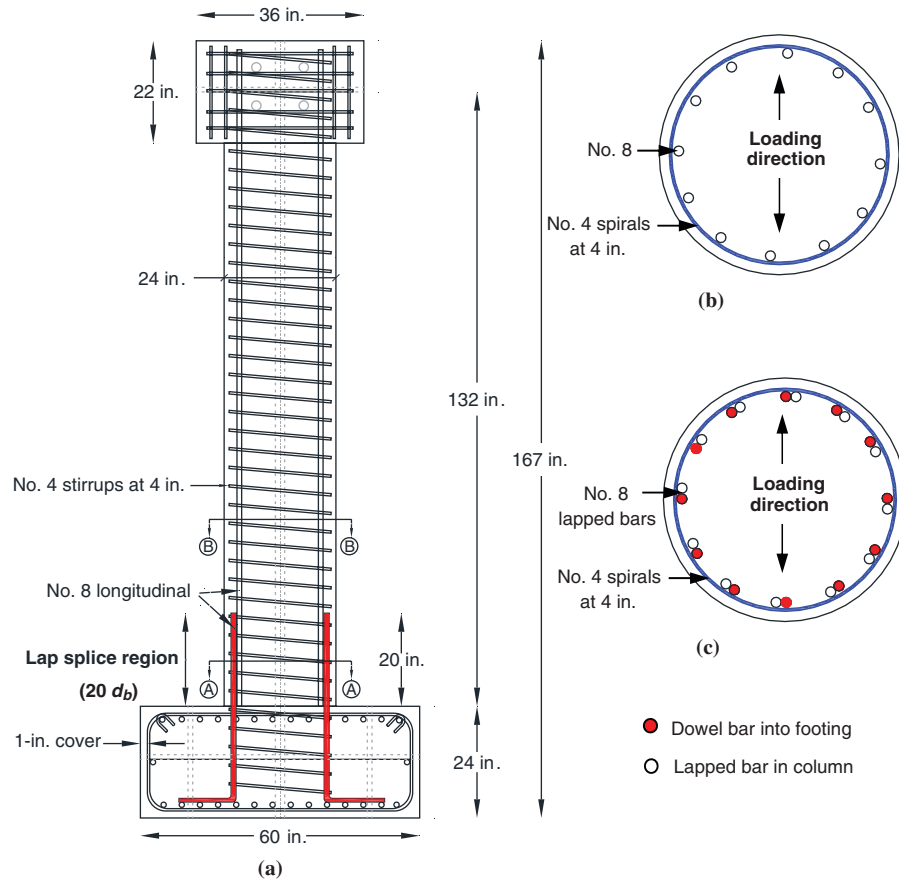
FIGURE 2 Geometry and reinforcement details of the original column: (a) original column reinforcement, (b) Cross Section B-B, and (c) Cross Section A-A [No. 4 (U.S.): No. 13 (SI); No. 8 (U.S.): No. 25 (SI); no. = number].

One half-scale circular RC column was constructed and tested to failure in the High-Bay Structures Laboratory at the Missouri University of Science and Technology. The column represents typical pre-1970s bridge piers with column longitudinal reinforcement lap spliced at column-footing joints. The lap splice length was equal to  $20 d_b$  or 20 in. (508 mm) for No. 8 deformed rebar. As shown in Figure 2, the total height of the column was 167 in. (4,242 mm) with an effective height of 132 in. (3,353 mm) measured from the top of the footing to the centerline of the applied force. The column of 24 in. (610 mm) in diameter was reinforced with 12 No. 8 ( $d_b = 25$  mm) deformed bars with a longitudinal reinforcement ratio of 2.08% and transversely confined with No. 4 ( $d_b = 12$  mm) spiral deformed bars at 4-in. (102-mm) spacing with a transverse reinforcement ratio of 0.9%. The measured yield strength of the longitudinal and transverse reinforcement bars

was 60.6 ksi (418 MPa) and 78.5 ksi (541 MPa), respectively. The concrete compressive strength was 6,340 psi (44 MPa).

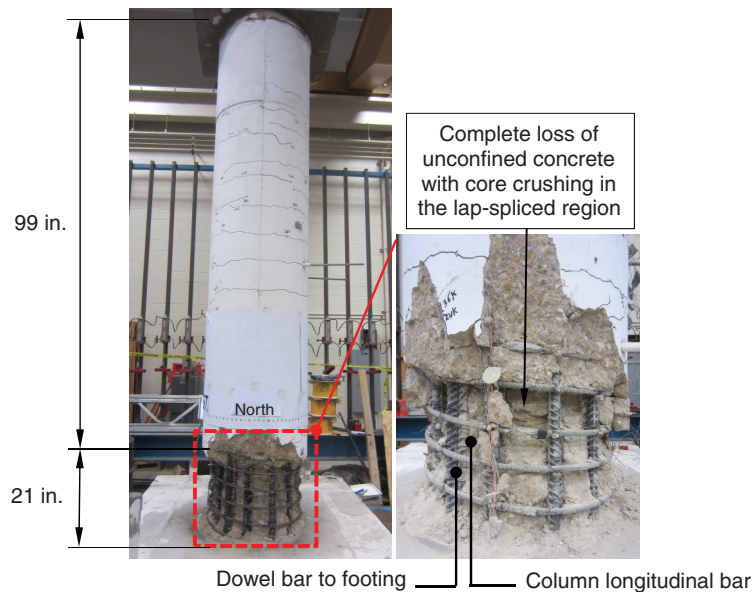
FIGURE 3 Original column damage state.

The original column was tested to failure under an incrementally increasing lateral cyclic load while subjected to a constant axial load of approximately 133 kips (592 kN). The applied axial load simulated the imposed superstructure load and corresponded to approximately 7% of the nominal axial capacity. Three symmetric cycles were applied at each loading stage. Load-displacement hysteresis loops showed significant stiffness degradation and strength loss (75% of peak strength) at the completion of testing. As illustrated in Figure 3, the column failed because of lap splice reinforcement slippage. The damaged state of the column would be classified as extensive or DS-5 for imminent failure—visible reinforcement bars and compressive failure of the concrete core edge (13, 14).

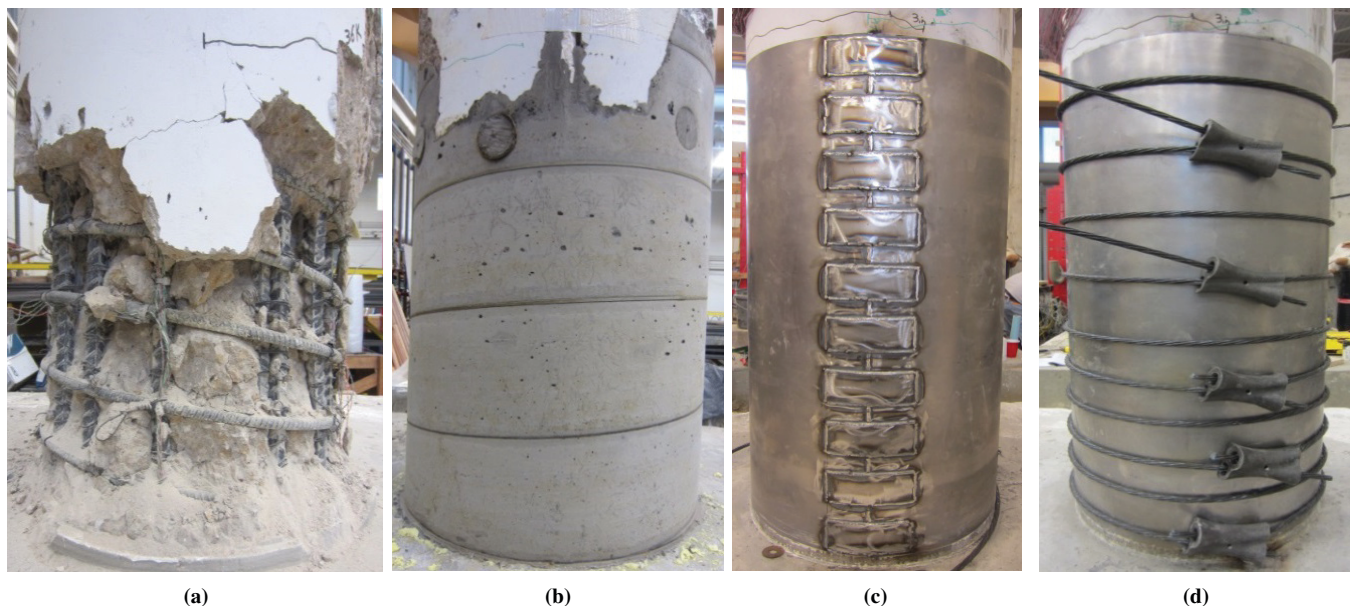
FIGURE 4 Repair procedure with the hybrid confining jacket: (a) damaged column, (b) patched column with repair grout, (c) sheet metal wrapping, and (d) prestressing strands application.

The damaged column was repaired in its bottom 48 in. (1,220 mm) with the proposed hybrid jacketing. To prevent premature compression damage in the jacketing, a 1-in. (25-mm) gap was left between the steel jacketing and the footing. The entire repair process was completed in four steps as illustrated in Figure 4:

1. Removing the cracked degraded concrete,
2. Placing repair grout to restore the column's original cross section,
3. Wrapping and welding the sheet metal around the column, and
4. Placing and prestressing strands around the steel jacket.

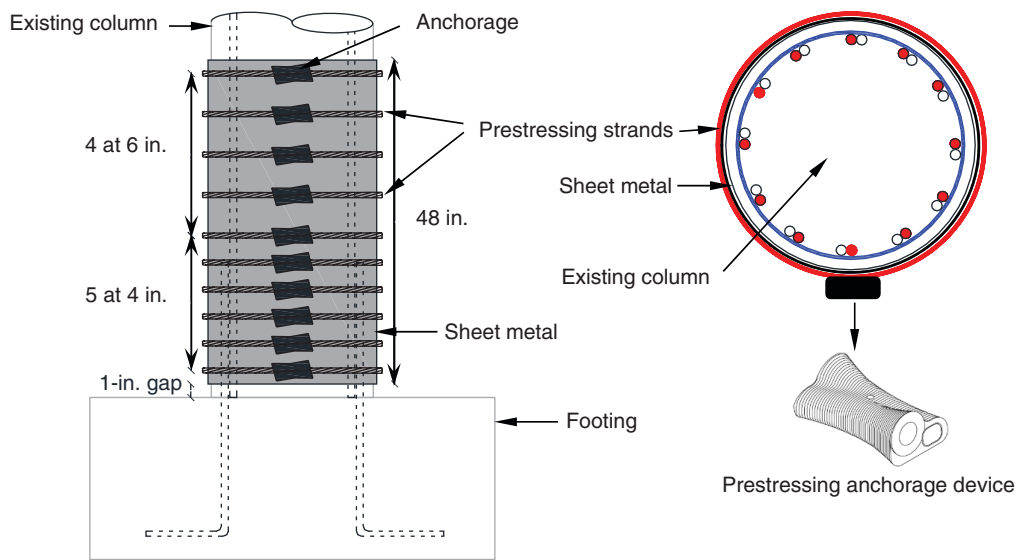
FIGURE 5 Hybrid jacket details.

After considering the repair performance objectives, shear design, lap splice design, and flexural design with required displacement ductility, the final design of the repaired column is presented in Figure 5. The repair design includes a sheet metal, 0.05 in. (1.27 mm) thick and 48 in. (1,220 mm) wide, and 10 prestressing strands in the plastic hinge region. Specifically, six strands at 4-in. (102-mm) spacing were applied over the lap splice region and the remaining four strands at 6 in. (152 mm) outside the spliced end. Each strand was prestressed up to 14 kips (62 kN) and anchored with a twisted ring anchor from Dywidag-Systems International, Toughkenamon, Pennsylvania.

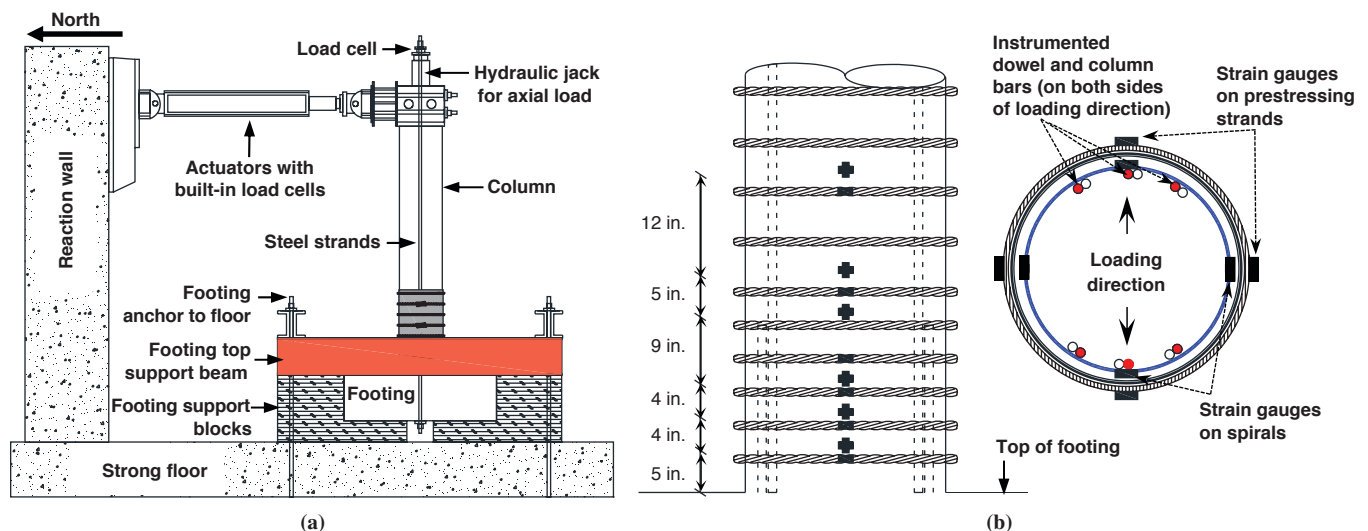
FIGURE 6 Column test setup and instrumentation: (a) column test setup and (b) strain gauge locations on hybrid jacket and rebars (■ = bidirectional strain gauge on sheet metal; ■ = unidirectional strain gauge on strands and spirals).

Linear variable differential transformers and string potentiometers were used to measure displacement profile, average rotation, and curvature of the column specimen. In addition, the repaired column was instrumented with a total of 110 strain gauges attached on the hybrid jacket (72 strain gauges) and the inside reinforcement

(38 strain gauges) as illustrated in Figure 6. Six prestressing strands (Nos. 1 to 4, 6, and 8 from the footing) were instrumented with four transverse strain gauges per strand at quarter points. The sheet metal was also instrumented with four transverse strain gauges and four longitudinal strain gauges at quarter points at each of six levels as detailed in Figure 6. Strain gauges on the inside reinforcement before repair were attached to dowel bars and longitudinal and transverse reinforcement bars.

The original and repaired column test setup as shown in Figure 6 was identical. A constant axial load of 133 kips (592 kN) was applied with seven prestressing steel strands through a polyvinyl chloride pipe at the column center. The strands were fixed at the bottom of the footing and at the top of the column loading stub. The axial load was applied with a hydraulic jack and was held constant through-

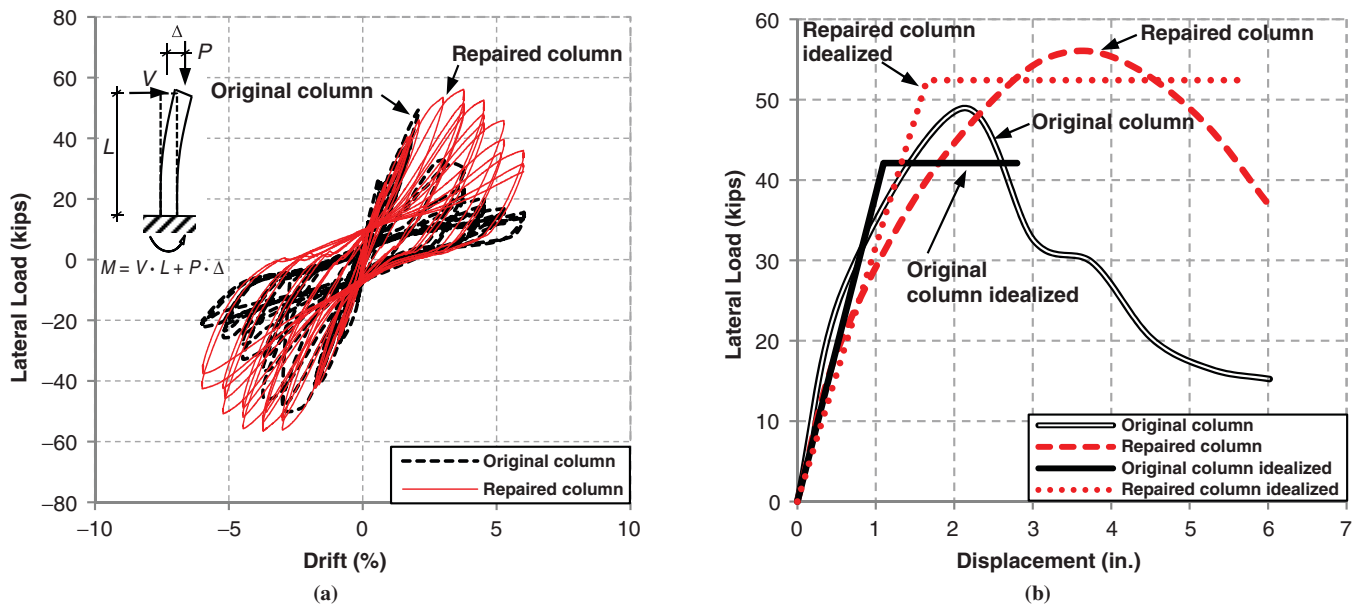
FIGURE 7 Cyclic and idealized force–displacement relationship of original and repaired column specimens: (a) hysteresis behavior and (b) measured and idealized envelopes (1 kip = 4.45 kN;  $M$  = moment;  $V$  = shear force;  $L$  = column height;  $P$  = axial force;  $\Delta$  = lateral displacement).

The load-drift hysteresis loops and the load-displacement envelopes of the two column specimens are compared in Figure 7, *a* and *b*, respectively. Figure 7*a* shows that the original as-built column specimen exhibited unstable hysteresis loops with rapid strength deterioration and pinched behavior caused by slippage of the lapped

In comparison with the original column, the repaired column resulted in 15% increase in lateral strength capacity with stable hysteresis behavior. Figure 7a indicates that the in-cycle strength degradation of the original column was enhanced to a cyclic strength degradation response of the repaired column. The in-cycle strength degradation can lead to structural collapse under dynamic loading. The repaired column experienced flexural cracks at the column–footing interface at approximately 1.5% lateral drift with the column confinement provided in the plastic hinge. At the same time, the stress in the column was effectively transferred into the footing without lap splice failure, resulting in surface cracks on the footing cover concrete at the location of the dowel bars. The lap-spliced reinforcement reached yielding, as verified by the strain measurements. Further loading enlarged the flexural cracks at the column–footing interface and, under cyclic effect, initiated severe cracking and pinching of the repair grout between the lapped bars. Eventually, crushing of the repaired grout was the governing failure causing the pullout between the dowel and longitudinal bars with no further yielding of the reinforcement.

They were evaluated on the basis of idealized, perfectly elastoplastic load-displacement envelopes as displayed in Figure 7b (12–14). For the original column, the measured load-displacement envelope was idealized by setting the initial slope to pass through the first longitudinal reinforcement yielding and altering the postelastic region so that areas under the measured and idealized envelopes were equal. For the repaired column, the initial elastic portion of the idealized envelope was acquired by connecting the origin of the measured envelope to a point at which the applied load is equal to one-half of the maximum measured load. The yield level was determined by equating the areas underneath the measured and idealized capacity curves. The three nondimensional response indices for strength, stiffness, and ductility are defined as follows:

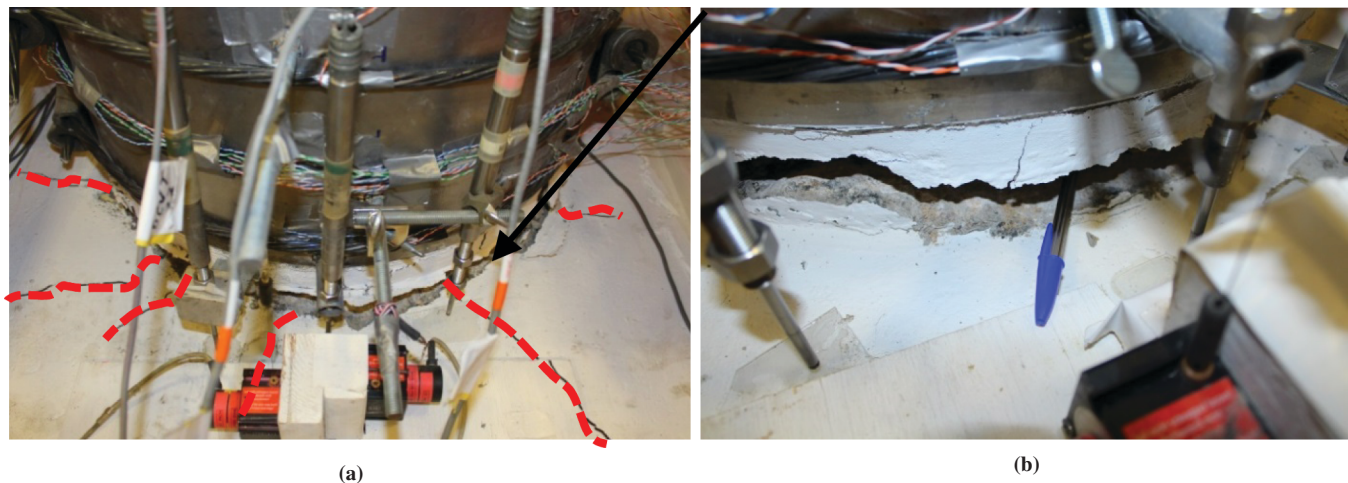
FIGURE 8 Concrete cracks associated with stress transfer through dowel bars at the column-footing connection: (a) cracks on footing and (b) damage in the plastic hinge (footing cracks marked with red dashed lines).

For crack formation, propagation, and distribution in the plastic hinge region, the original and the repaired columns were quite dissimilar. For the original column, the flexural and vertical splitting cracks with limited plastic hinge progression over the height almost equal to the column diameter were the primary observed damage. The cracks mainly resulted from the bond failure of dowel bars at the column–footing connection. No sign of stress transfer from the dowel bars to the footing was observed.
